FITTING INSTRUCTIONS: INSTALLING YOUR NEW EXEDY CLUTCH

General Fitting Instructions

GET IT RIGHT THE FIRST TIME WHEN INSTALLING YOUR NEW EXEDY CLUTCH

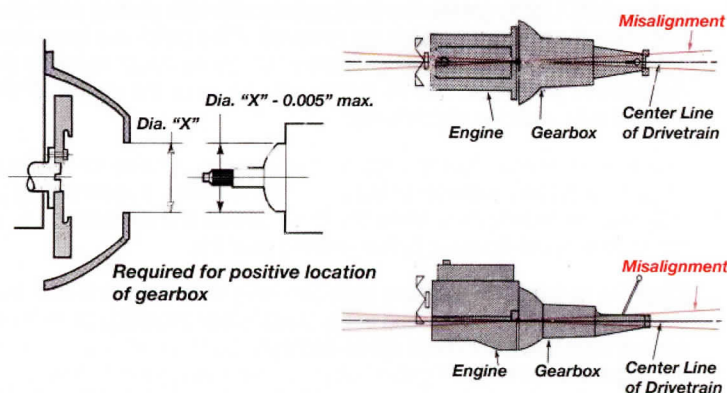
Hanging the Gearbox

8: Re-fit the gearbox, taking care not to bend the clutch disc. Never hang the gear box on the clutch disc or use any force to align the gearbox shaft.

8. Refit gear box, taking care not to bend the clutch disc. Never hang the gear box off the clutch disc or use any force to align gear box shaft.
9. Check all bell housing dowels are in correct position and tighten bell housing bolts. Ensure there is no dirt or foreign material between the mating surfaces of the engine and the bell housing.

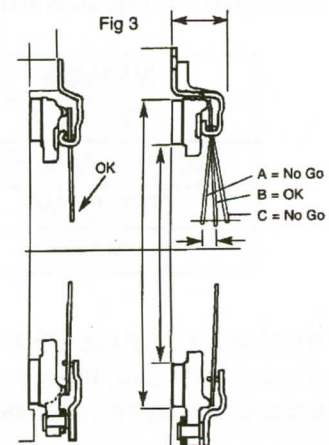
7: When the cover assembly has been torqued securely to the flywheel, ensure that the diaphragm tips (in the case of a lever type cover assembly, the release lever tips) are in a parallel position in relation to the flywheel (see Fig 3). Do not go over centre of the parallel position.

7. When the pressure plate has been torqued down securely to the flywheel, ensure that the diaphragm tips (in the case of a lever type cover assembly, the release lever tips) are in a parallel or slightly upward position (see Fig 3) and do not go over center of the parallel position.

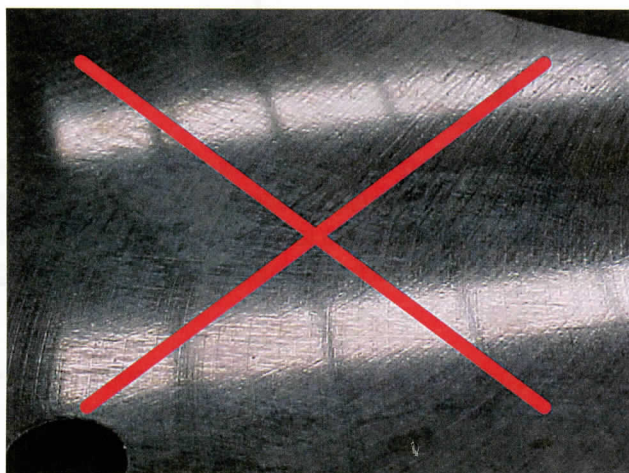
Fig: 4. "This flywheel has been machined with a polish finish which may promote clutch shudder".

With the demise of Asbestos in the friction material used in clutches and the introduction of alternate materials, it is paramount that attention to the flywheel surface finish be maintained. To enhance the performance of the clutch and reduce the risk of shudder, the flywheel surface finish should replicate that of the pressure plate friction face of the new EXEDY cover assembly. Preferably by grinding; remove all traces of "hot spots" and/or grooving and maintain the correct flywheel profile (i.e. flat, raised or recessed). Any deviation may have a detrimental influence on the operation of the clutch.

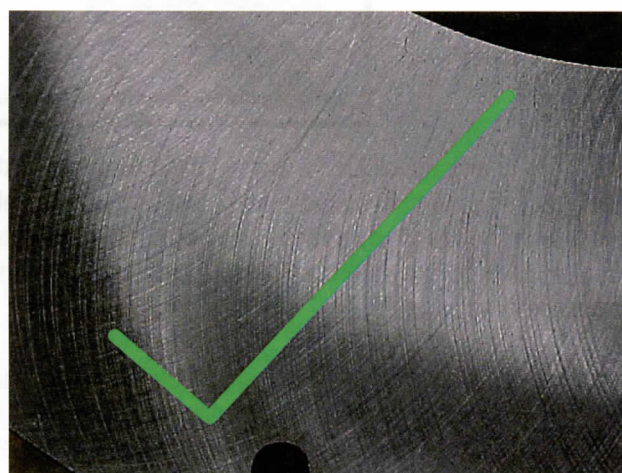
Fig: 5. "This flywheel has been ground to replicate the surface finish of its mating cover assembly which will reduce the risk of clutch shudder".
